A 'lifeline' for pipelines

Kevin Cato, Insitu Pipeline Systems, USA, provides an example of insitu pipe coating giving new life to an ageing pipeline.

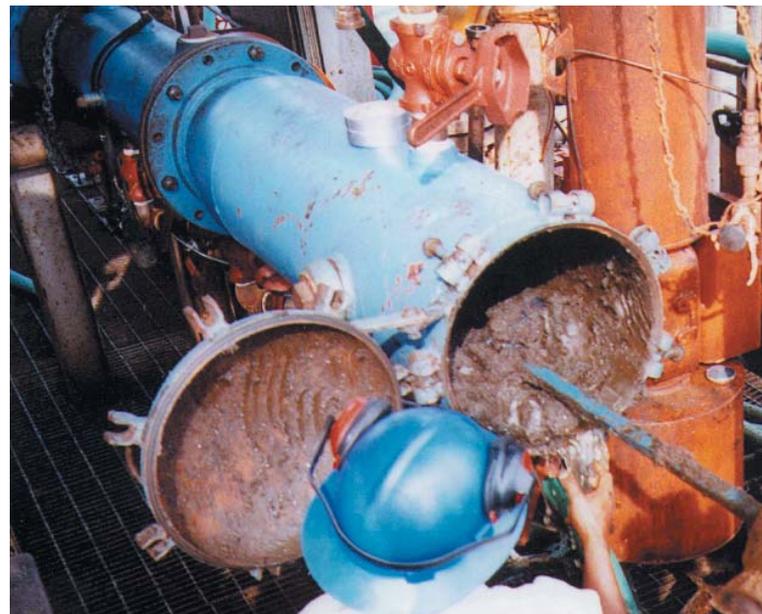
Figure 1. Removing the wax from inside the pipeline.

- The chemical cleaning process began by displacing the seawater from the line. Paraffin solvents were batched between bi-directional pigs to soften and remove all traces of paraffin.

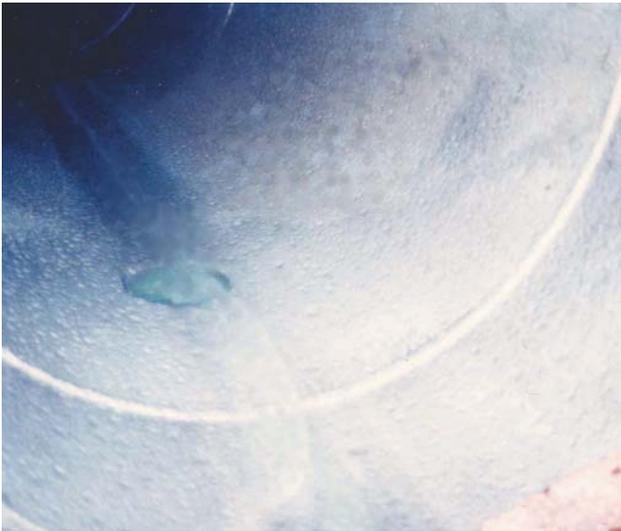
Figure 2. The pipeline once it had been cleaned.

- Hydrochloric acid (HCL) was batched between two acid resistant pigs, at a concentration of 15 - 25%. The acid strength was verified by titration before it was loaded into the launcher and tested again when the batch arrived at the receiver. After running several batches of HCL, samples were collected and indicated that the acid strength had no longer depleted and the solid content was negligible. Based on this information, the line was considered clean.

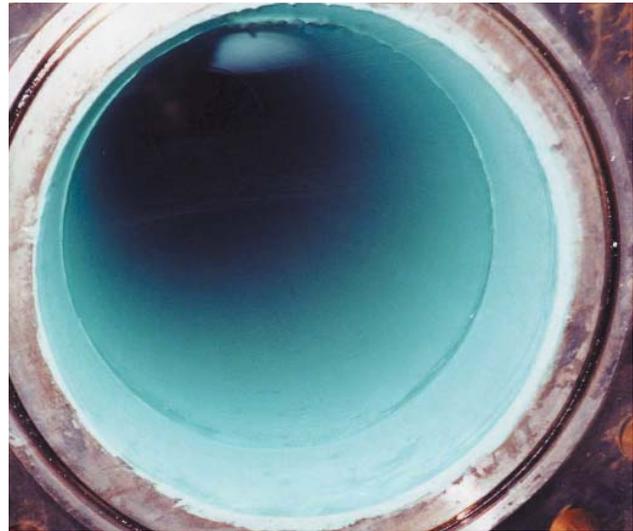
Figure 3. The pipeline once it had been in situ coated.

To complete this coating project, four coating runs were required. Each coating run applied an average of 2.5 mils (DFT) per run. This provided a final dry film thickness of 10 mils. Upon completion of the final coating run, the pipeline was subjected to a slow purge of wet air for a period of five days.
